Cadastral Sheet 33C
2/d
Borough of Chaguanas
County of Caroni

PLAN of certain boundary lines in the Borough of Chaguanas
Surveyed by me, with due authority, in August 2011 for Yardo Bhagan
In accordance with Regulation 25 (1) of the Land Surveyors' Regulations 1998,
I certify that this plan is correct.

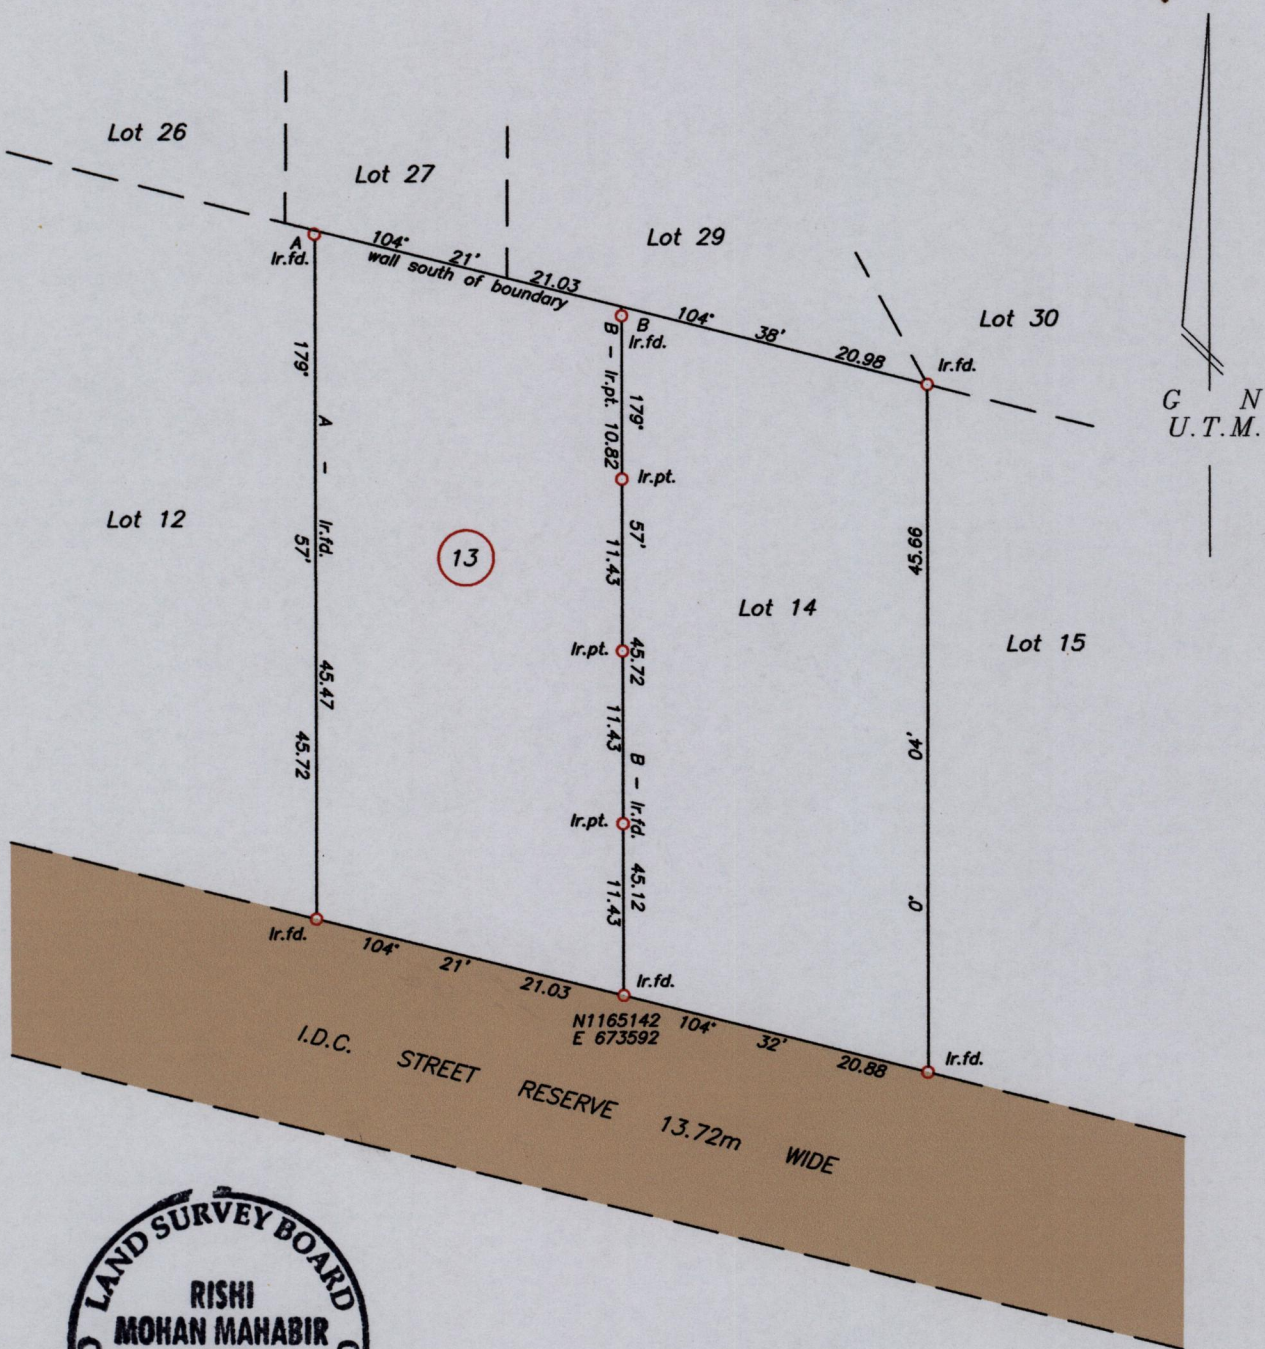
Irons A & B were found on the southern edge of the existing wall

Co-ordinates are UTM zone 20N Naparima Datum +/-5m
obtained by indirect tie to Trig#1125 (see plan R.H.229)
Bearings are U.T.M. grid based on boundary irons found

SCALE 1/500
Distances are in metres
